FIRE PERFORMANCE EVALUATION OF SIMPSON STRONG-TIE CONNECTION HARDWARE LOADED BEAM-TO-COLUMN CONNECTION WITH A CLT PANEL FLOOR, TESTED IN GENERAL ACCORDANCE WITH ASTM E119-24, STANDARD TEST METHODS FOR FIRE TESTS OF BUILDING CONSTRUCTION AND MATERIALS

FINAL REPORT Consisting of 22 Pages

SwRI[®] Project No. 01.29393.01.001a Test Date: April 18, 2025 Report Date: July 3, 2025

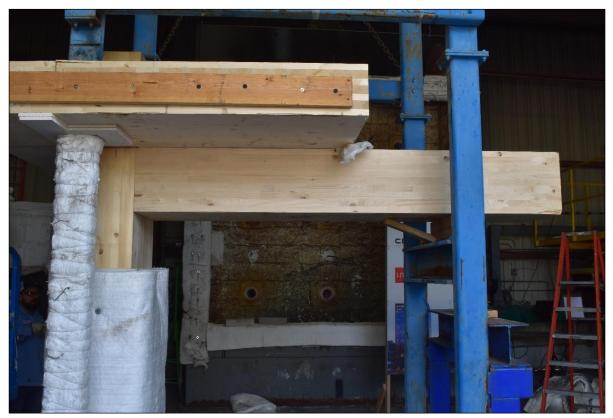
Figure B-2. Beam and Column, and CLT Panel Installed in Frame.

SwRI used a steel self-reacting load frame that supported the base of the column on one end inside the furnace and the loaded beam on the other end outside of the furnace. The portion of the load frame that was inside the furnace was insulated and water-cooled to protect the load frame from the heat exposure. The load was applied with a servo-controlled hydraulic actuator attached to the upper load frame beam. The load output was calibrated to input pressure values prior to the test, and pressure was monitored to maintain the target load during testing. A string potentiometer was used to measure the deflection of the test assembly during the test. An additional jack was placed on the underside of the beam outside of the furnace to allow for the beam to stay level as it deflected.

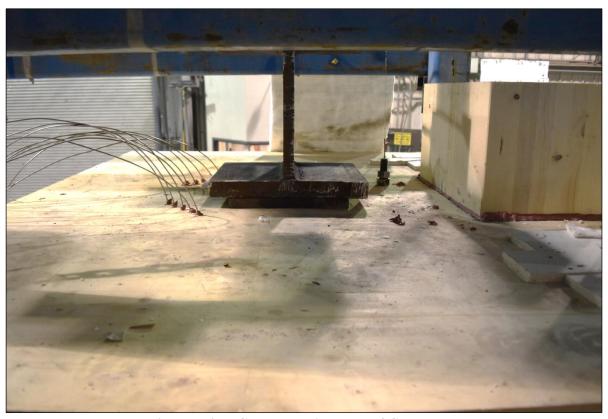
Figure B-3. TCs Installed into Top of CLT Panel.

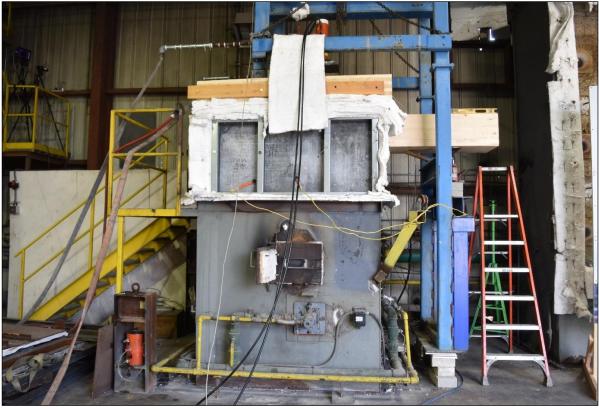
Figure B-4. View of Assembly prior to Testing.

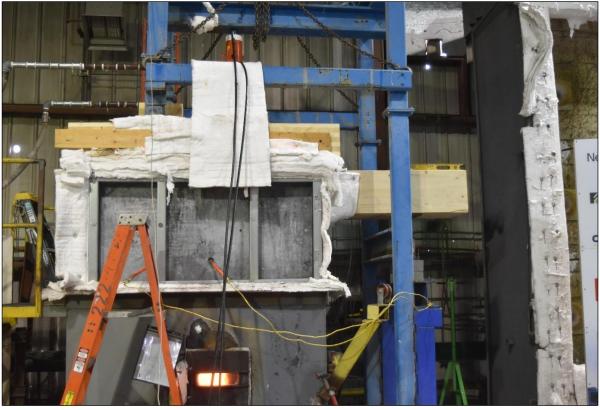
Figure B-6. View of Assembly at End of Test.

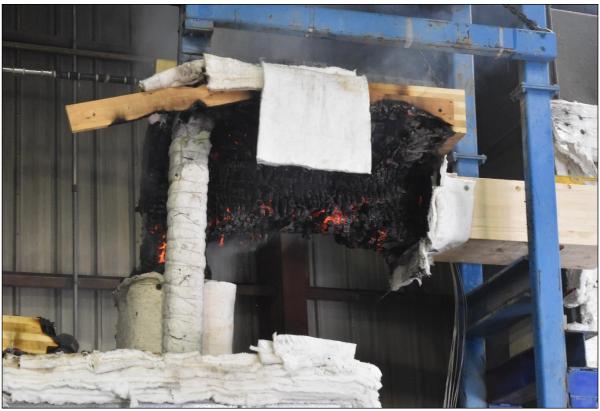
Figure B-7. View of Assembly during Removal from Furnace, following Removal of Rear Section of CLT.

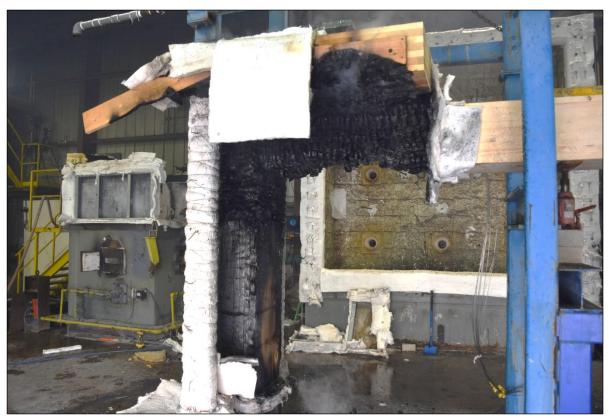
Figure B-8. View of Assembly after Cool-Down.

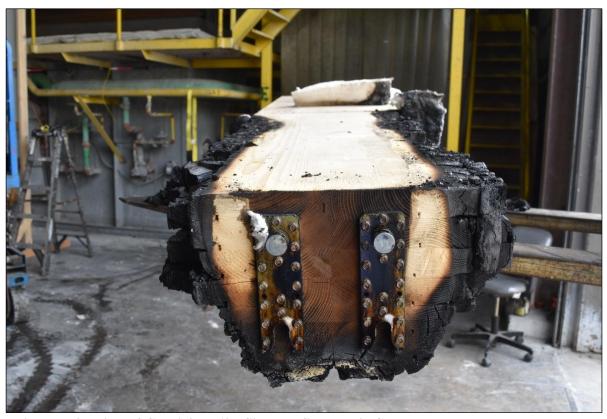
Figure B-9. View of CBH2.3X7.63B Simpson Strong-Tie Concealed Beam Hangers, Posttest.

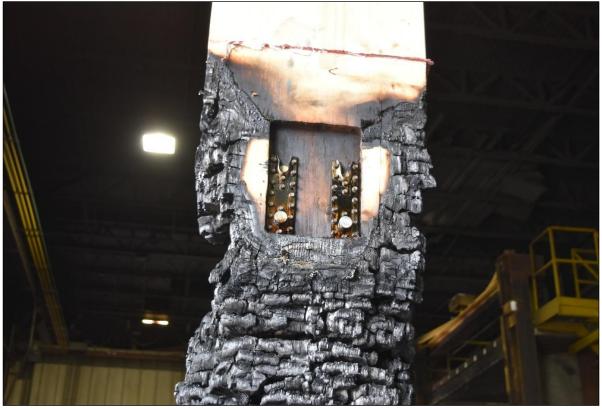
Figure B-10. View of CBH2.3X7.63C Simpson Strong-Tie Concealed Beam Hangers, Posttest.

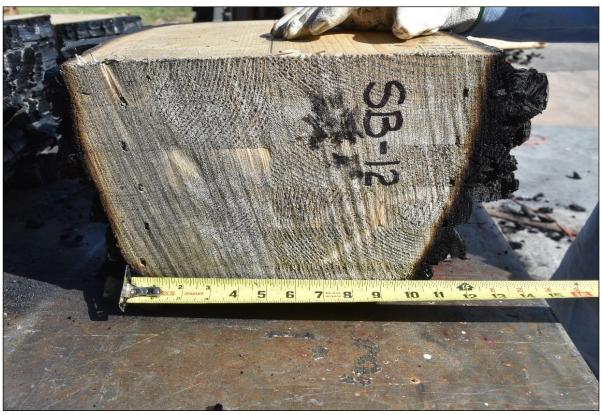
Figure B-11. View of Beam Cut 12 in. from End of Beam, Exposed 10 in. of Good Wood.

Test Items	Measurements
Beam Original Dimensions	20.47×14.17 in.
Posttest Beam Measurements	10×8.8 in.

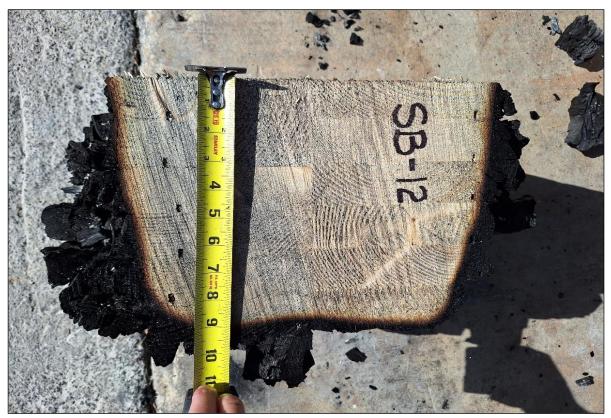
Figure B-12. View of Beam Cut 12 in. from End of Beam, Exposed 8.8 in. of Good Wood.
